Intel[®] Mobile Celeron[™] Processor at 466 MHz, 433 MHz, 400 MHz, 366 MHz, 333 MHz, 300 MHz, and 266 MHz Specification Update

Release Date: June 2000

Order Number: 244444-015

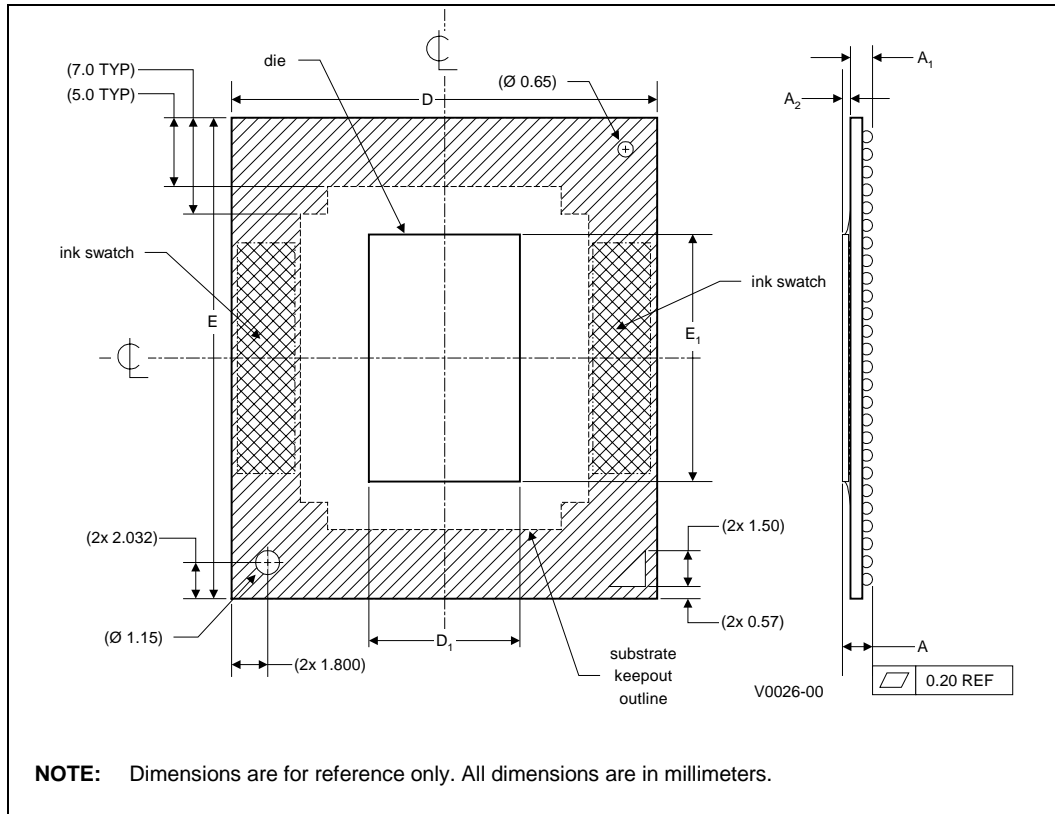
Figure 5.3. Surface-Mount BGA1 Package—Top and Side View

The following table and figures show the updated mechanical specifications for the BGA1 package, listed as Table 5.2, Figure 5.3 and 5.4, respectively, in the *Intel® Mobile Celeron™ Processor in BGA Package at 333 MHz, 300 MHz and 266 MHz* datasheet.
